IN RE PACIFIC FERTILITY CENTER
LITIGATION

Master Case No. 3:18-cv-01586-JSC

PLAINTIFFS' TRIAL BRIEF

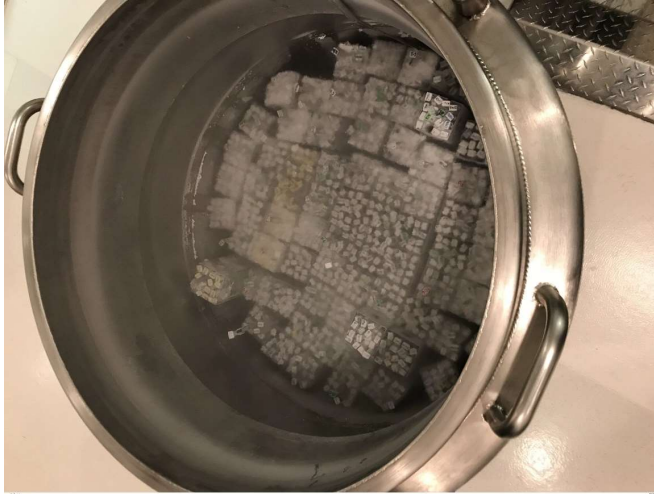
Normal Tank

After PFC staff finished removing eggs and embryos from Tank 4, they saw why the lid had been stuck in place: Tank 4's inner vessel had begun to implode. (*Id.* at 41-42, 114.) And in the hours after the tank was emptied, it continued to implode until it was a crumpled mass of stainless steel:

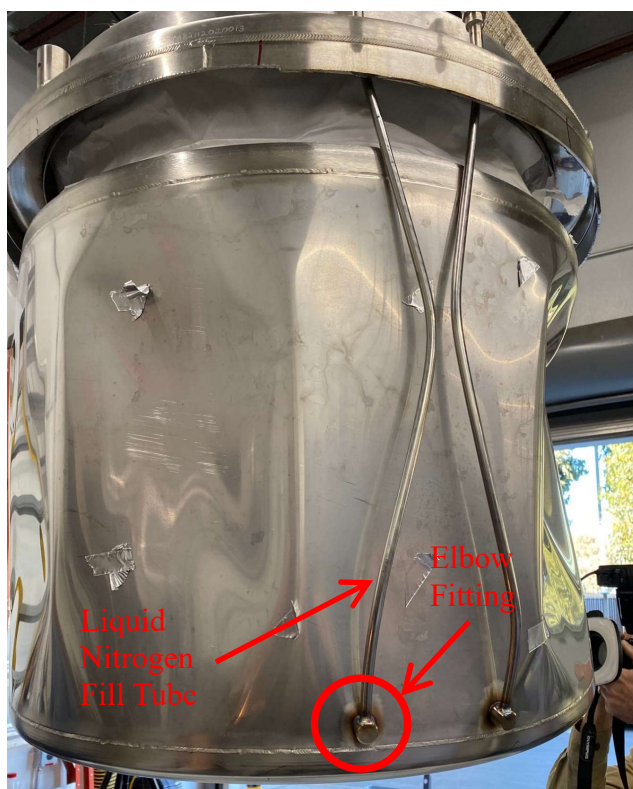
9 Post-mortem testing conducted by experts retained by Plaintiffs, Chart, and PFC disclosed why
10 Tank 4’s vacuum suddenly failed. (Trial Ex. 83 (11/06/20 Kasbekar Report, as amended on 11/30/20
11 (“Kasbekar Am. Rep.”)) at 10-36.) The testing revealed a crack in a weld on the inside of the tank that
12 connects the tank’s fill tube to its inner vessel. (*Id.* at 16-19.) Chart’s cryogenic tanks are manufactured
13 with a metal tube that can be used to fill the tank with liquid nitrogen. (*Id.* at 20.) That tube runs from
14 the top of the tank, down through the tank’s vacuum insulation layer, and into the inner vessel near the
15 bottom of the tank. The picture below was taken after Tank 4’s outer vessel was removed; the red circle
16 shows where its liquid nitrogen fill tube connected to the inner vessel through an elbow fitting:
17
18
19
20
21
22
23
24
25
26
27
28

Liquid nitrogen tube feeds into Tank 4's inner vessel

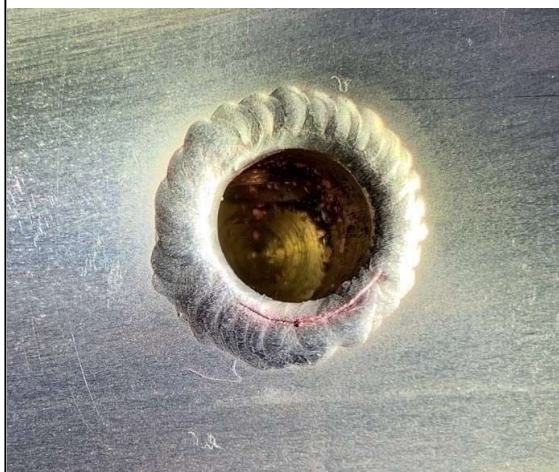
(See *id.* at 25.) The fill tube's elbow fitting was welded on the inside of Tank 4's inner vessel. That's the weld that cracked, as shown below. The image on the left is a close-up up the weld, with red dye indicating a crack, and the image on the right is a CT scan of the weld showing the through-wall crack that propagated through the entire thickness of the weld. (*Id.* at 19, 42.)

Close up of weld – red dye indicates a crack

The crack in Tank 4's interior weld allowed liquid nitrogen to seep from its inner vessel into its vacuum-insulation layer, where it was warmed by the surrounding laboratory air, transformed from liquid to gas, and expanded to almost 700 times its original volume. (*Id.* at 59-60.) The presence of so much nitrogen gas trapped between the tank's inner and outer vessels exerted substantial pressure, causing the inner vessel to implode. (*Id.*) More importantly, the presence of nitrogen gas destroyed the vacuum insulation that had been impeding heat transfer from the tank's room-temperature environment. Heat transfer ordinarily occurs when molecules bump into other nearby molecules and transfer some of their energy. When Tank 4's vacuum layer was still intact, it contained very few molecules, so heat transfer from the outside environment to Tank 4's inner vessel was minimal. But once that vacuum layer filled with high-pressure nitrogen gas, the number of molecules facilitating heat transfer greatly increased—and Tank 4 could no longer protect its contents from the outside air. (*See Kasbekar Am. Rep.* at 38.)
